Leak Detection & Repair

COMMONWEALTH UTILITIES CORPORATION WATER DIVISION

Leak Detection and Repair Phase II

Leak Detection and Repair – Phase II

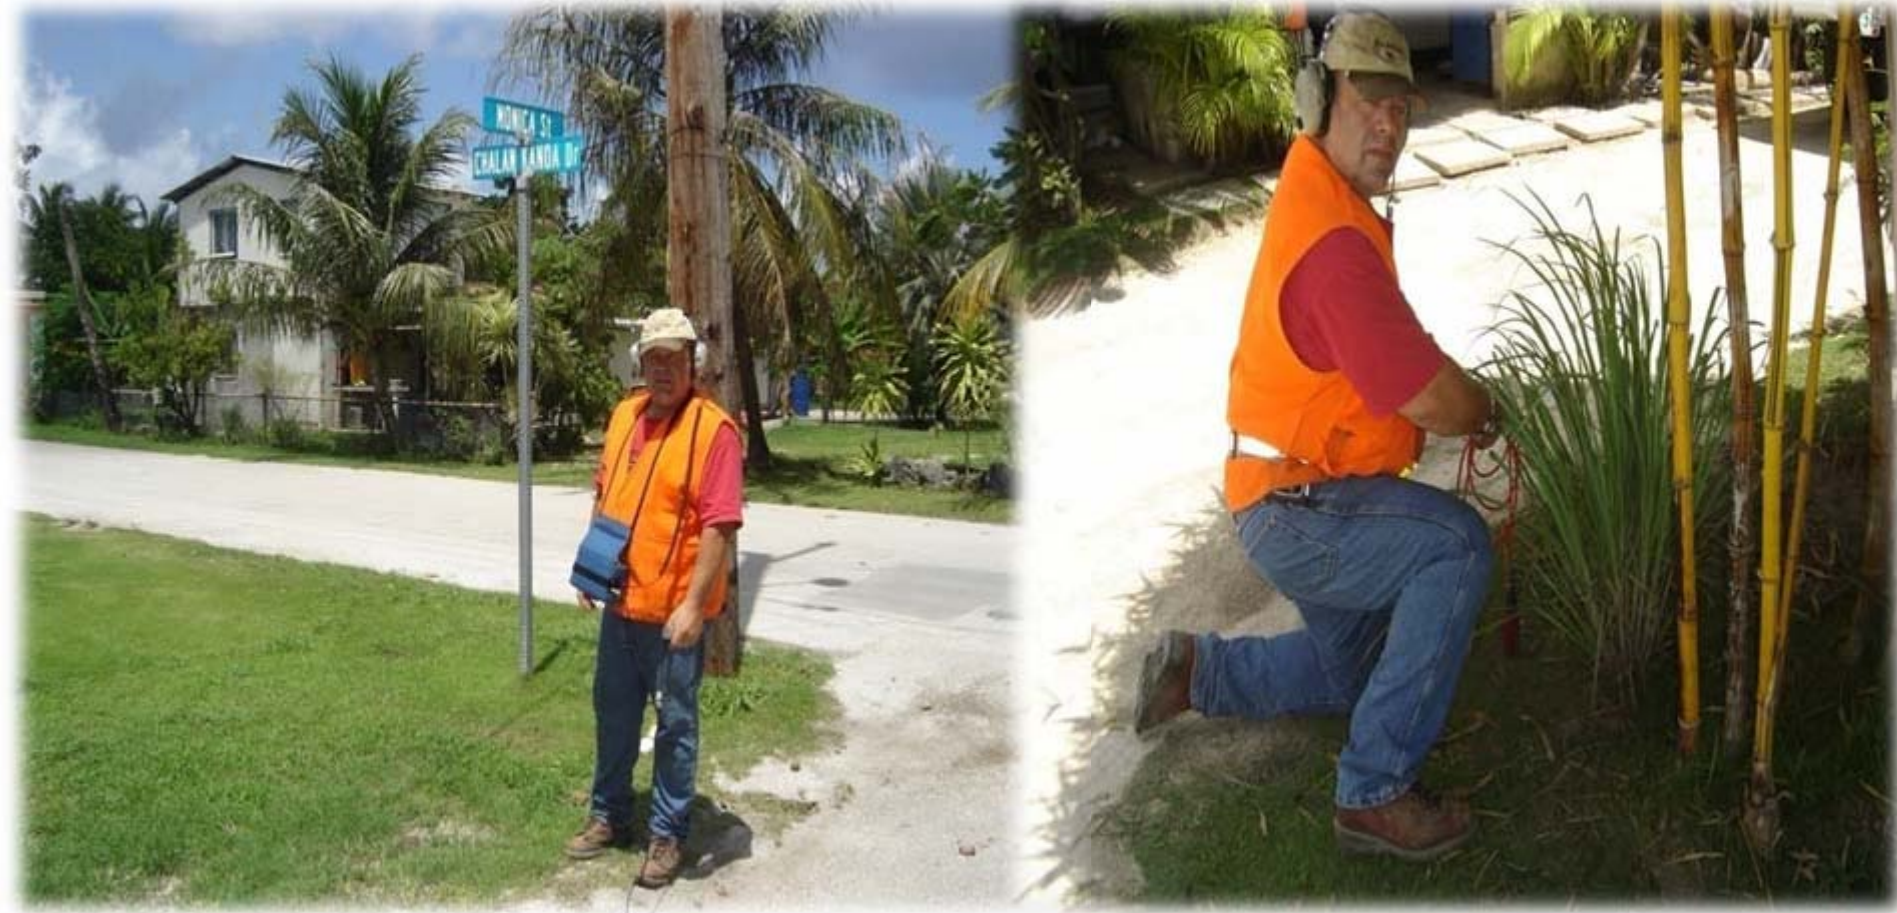
Chalan Kanoa

Leak Detection and Survey (Point to Point)

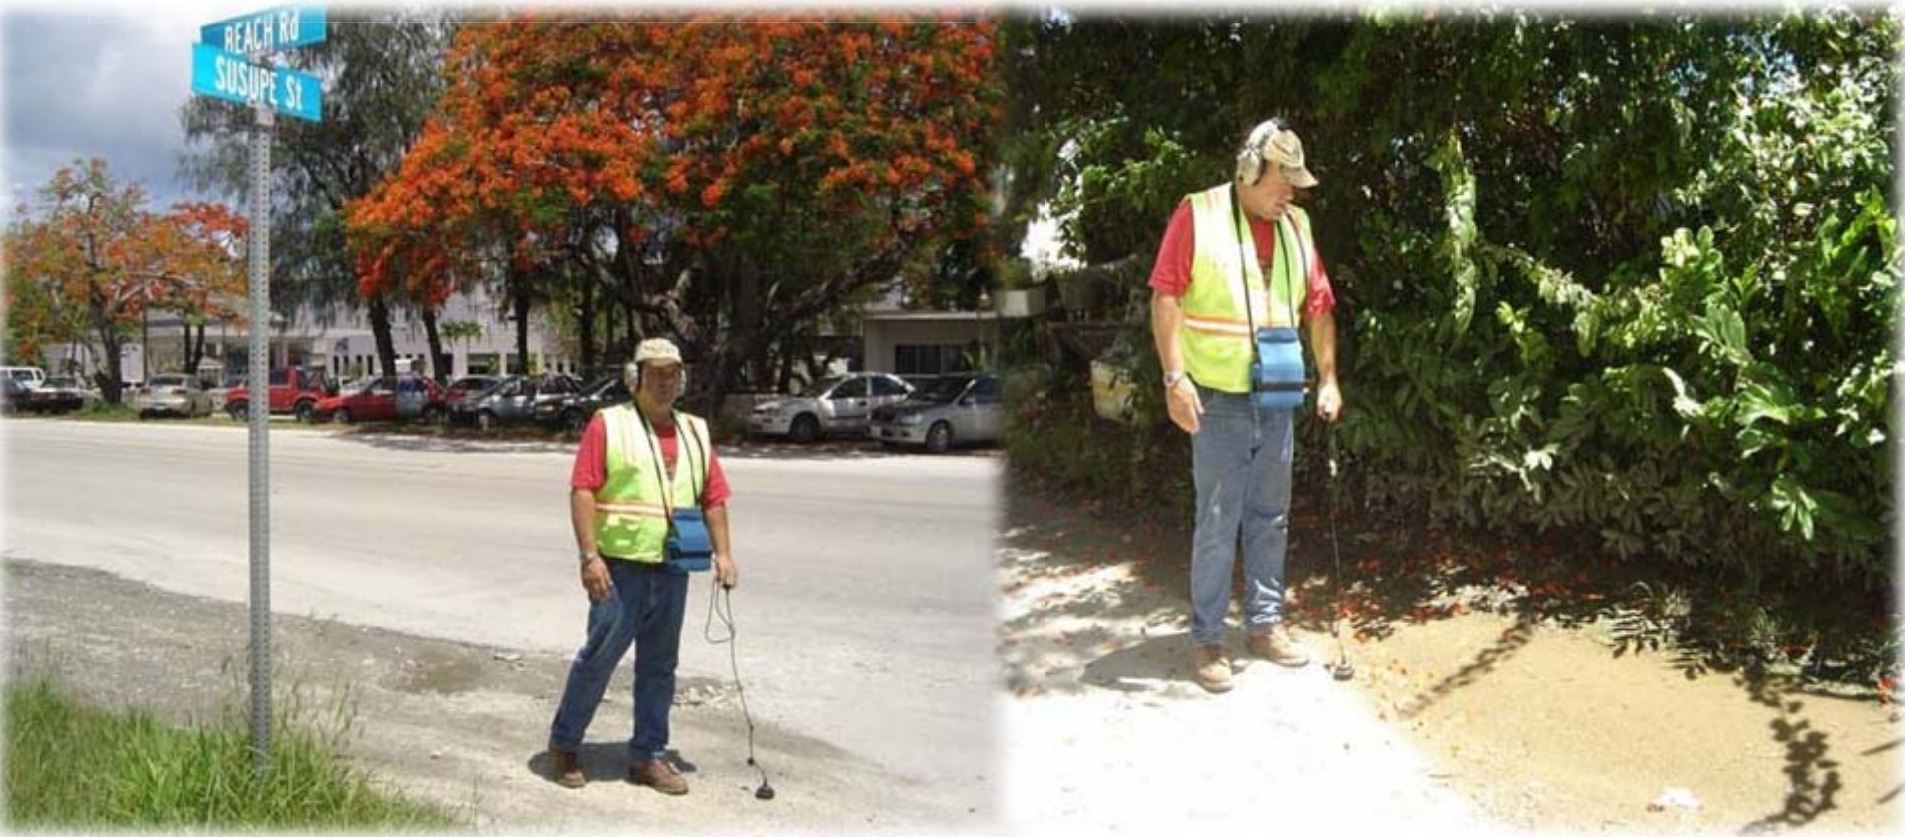
Susupe

Leak Detection and Survey (Ground Microphone)
